French River Connection

2018 Water Quality Monitoring Report

December 15, 2018

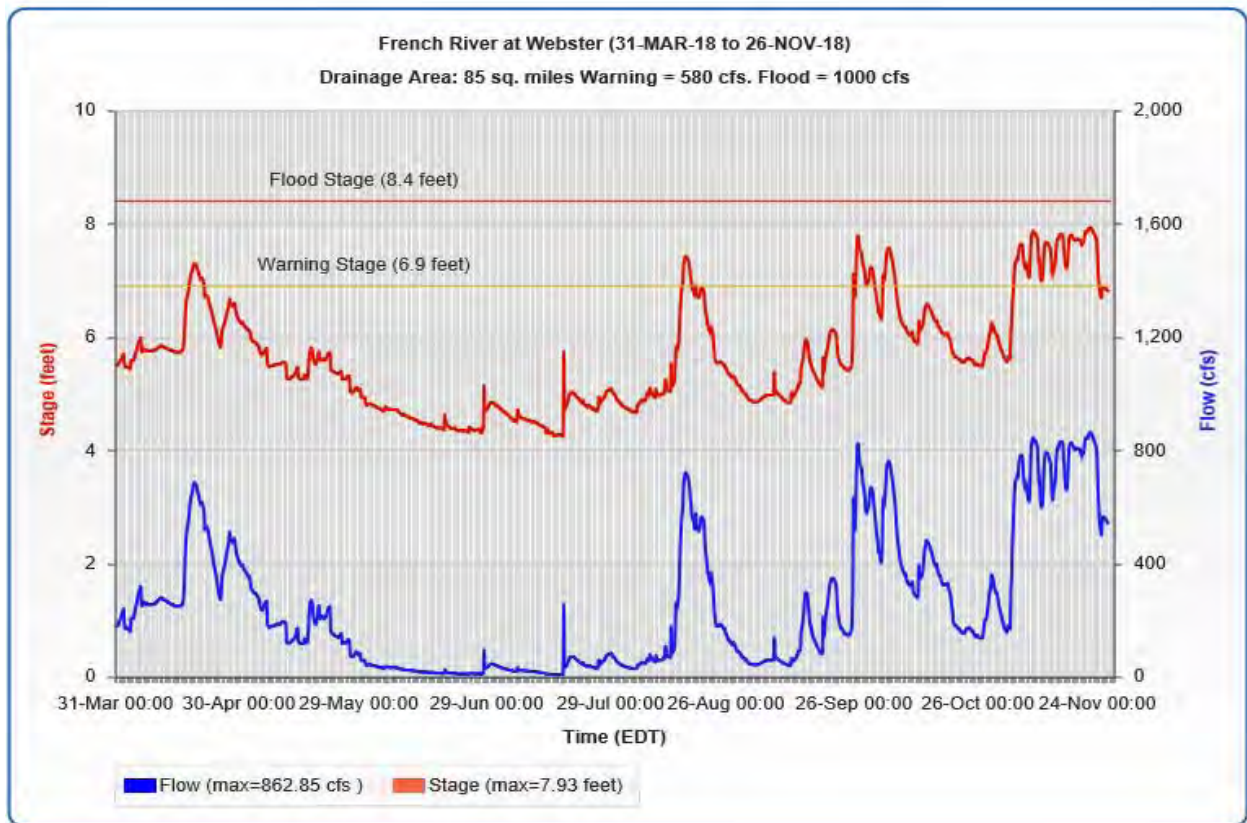
The flow rate at the time of sampling can possibly impact parameter values. The flow rate of the French River at the Army Corp of Engineers gage site in Webster, MA is illustrated in the graph below. The flow rate at this gage station is in general indicative of the flow rate at all sample sites.

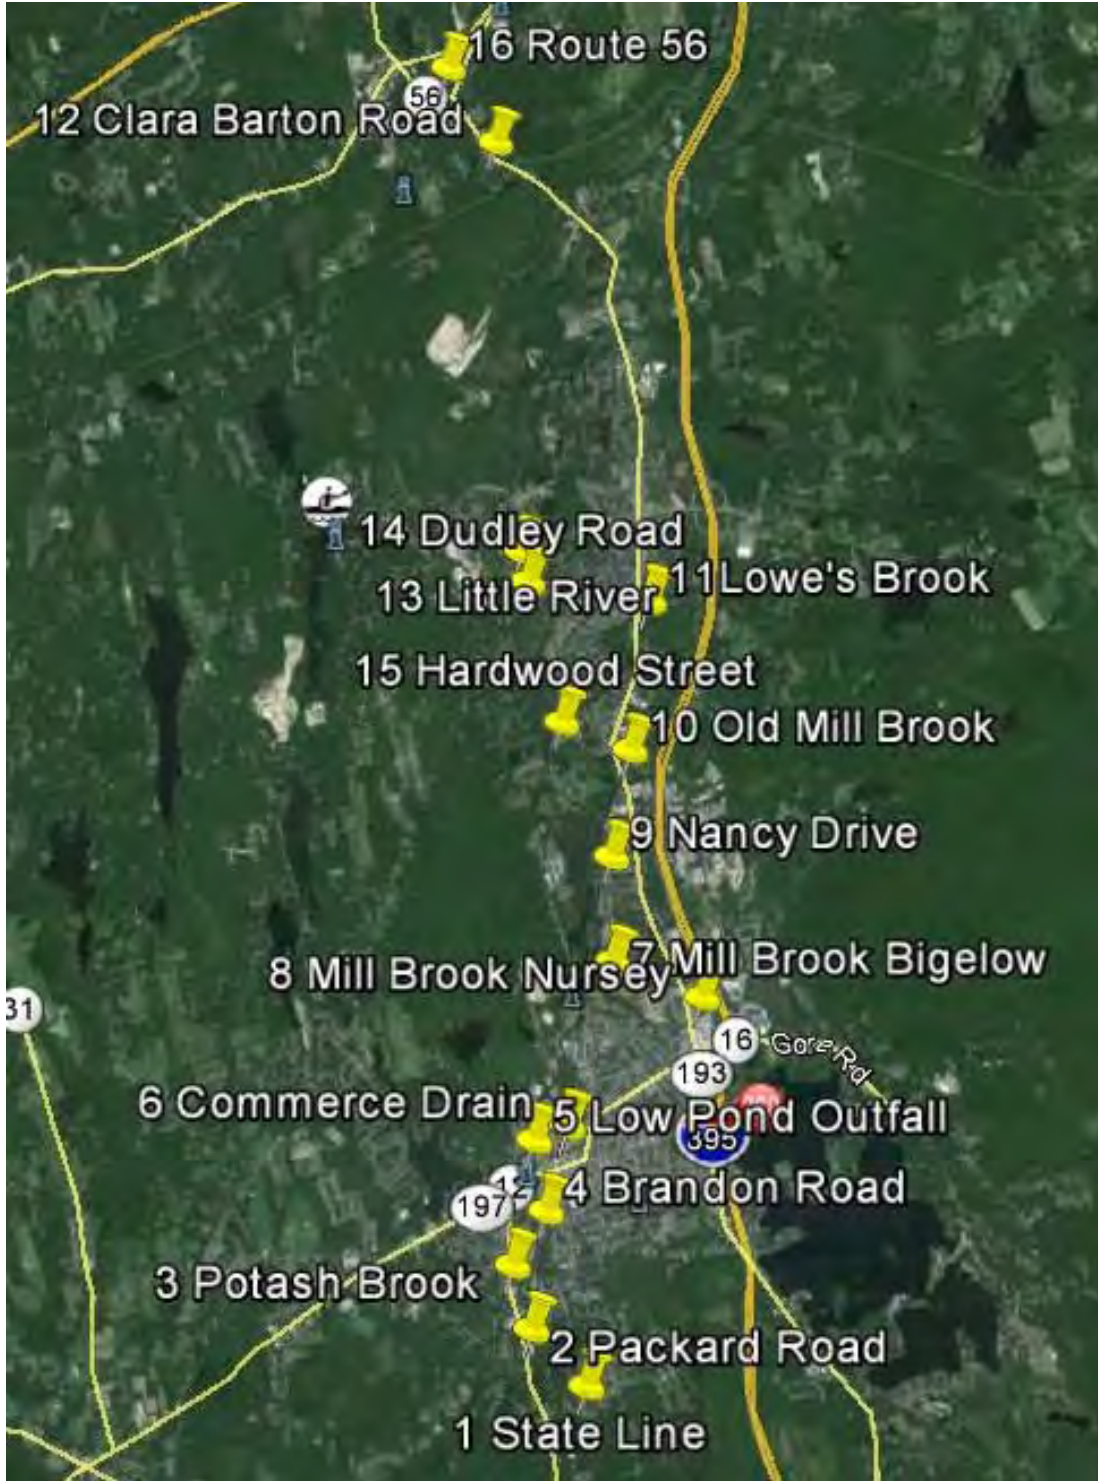
The following pages contain a brief report for each of the sixteen sites we monitor, as shown on the map.

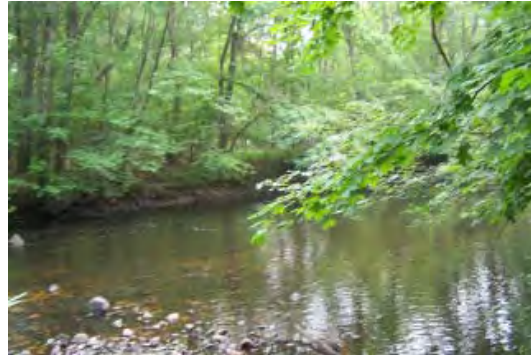
State Line, Webster N 42°02'27.5" W 71°53'02"

Stateline (boundary): this is a measure of water quality, below the Webster WWTP, as the main stem leaves the state. This site is chosen because it is on the state line. It is reached by parking where the P&W active rail line crosses Perryville Road in Webster and walking diagonally downstream until the river is reached.

Water at this site is clear and odorless. Elevated conductivity has been observed in previous years, and was also the case this year. Chloride sampling was conducted on 8/1 and 8/27 with the following results. 67.2 ppm on 8/1 and 63.1 ppm on 8/27.

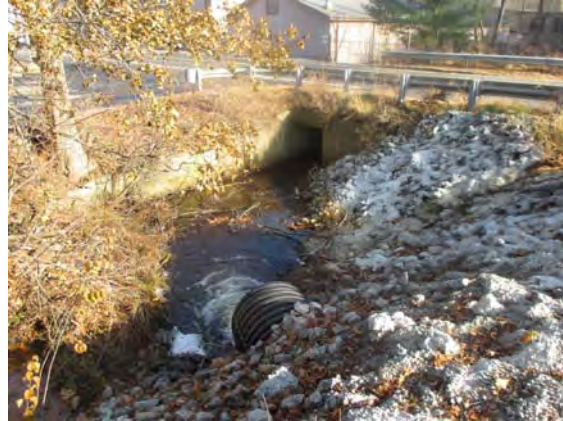
Packard Pond Outflow, Dudley N 42°01'1.0" W 71°53'25.5"

Packard Pond (impact): carries a significant volume of water and drains Ardlock Acres conservation area and an area behind the Dudley transfer station, which may be a source of pollution. Park at the junction of Carpenter Road and Route 12 in Dudley, and monitored on the west side of the culvert.

Water at this site is normally clear and odorless. There are small articles of trash scattered about, and plants along the sides of the channel. DO reading was below State standards once.

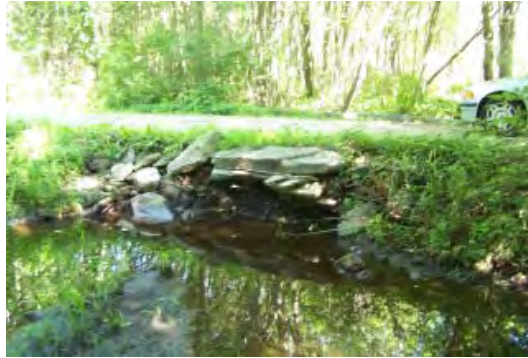
Potash Brook, Dudley N 42°02'13.5" W 71°53'33.3"

Potash Brook : carries a significant volume of water and drains an area west of Merino Pond which is partly residential and partly agricultural and may be a source of nutrient runoff. Turn off Route 12 onto New Boston Road and then right into the Dudley Pumping Station, and monitor on the south side of the bridge.

Water here is clear and odorless. Water temperatures here are generally the lowest we observe. High Conductivity was observed three times this year.

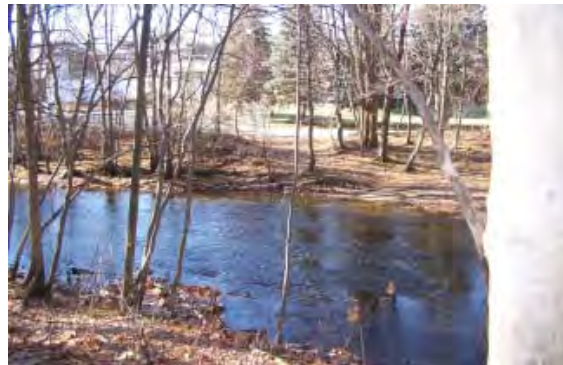
Brandon Road, Dudley N 42°02'30.2" W 71°53'14.8"

Brandon Road (reference): At this location we can take data upstream of the Webster Wastewater Treatment Plant. Drive into the Ethan Allen Mill Complex north of the office and proceed directly to the river, just downstream from the Hill Street bridge

Water here is clear and odorless. High Conductivity on 6/26 maybe related to low flow.

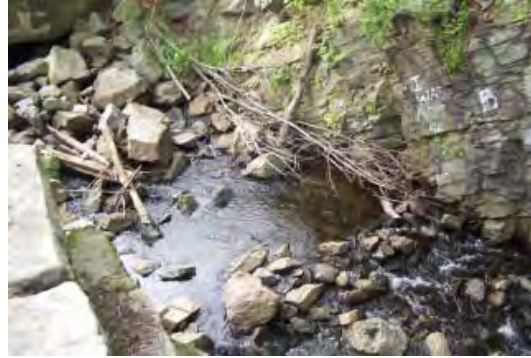
Low Pond Outflow, Dudley N 42°02'59.8" W 71°53'16.3"

Low Pond outflow (impact): carries a significant volume of water and drains a string of ponds including Low Pond and Merino Pond, around which there are significant residential developments which may be a source of runoff. Park on the north side of Stevens Linen in Dudley in the large parking lot and proceed to the right to the tailrace. Monitor where it emerges from under the building.

Water here is generally clear and odorless. There is some trash in the channel. The higher levels of pH and low conductivity are characteristic of this site.

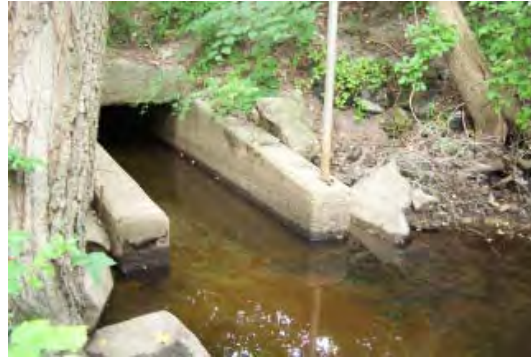
Commerce Parking Lot Storm Drain, Webster N 42°03'01.4" W 71°53'00.6"

Commerce parking lot storm drain (impact):
This continually running storm drain in downtown Webster has exuded an odor detectable at times and nearby rocks have exhibited an orange deposit. High E. Coli counts were found at this site. This is a possible point source of pollution. Enter the public parking lot at Tracy Court and go to the southwest corner. Monitor the storm drain outflow.

There is some trash scattered about. Consistently higher levels of conductivity and pH characterize this site. The odors and deposits that were observed at the site in earlier years have disappeared.

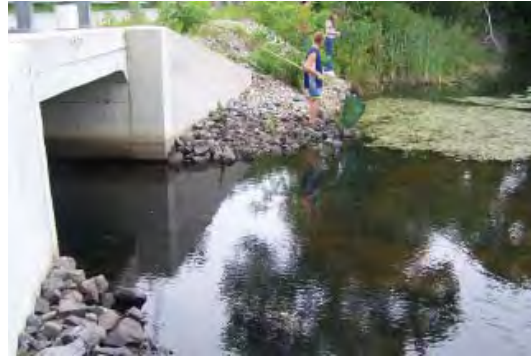
Mill Brook at Bigelow Road, Webster N 42°04'00.8" W 71°52'31.9"

Mill Brook at Bigelow Road (impact): As the outflow from Webster Lake, carries a significant volume of water. This station is downstream from a former stump grinding operation, which operated on raw material of unknown origin and character, and added chemicals to its product, and may have affected the chemistry of Mill Brook. Park near the bridge over Mill Brook on Bigelow Road, and monitor on the east side of the bridge.

Water here is very clear and odorless. There is considerable trash scattered about, and plants seen throughout the season include milfoil, algae, water lilies, cattails, and many others. Flow here is affected by operation of a dam controlling the level of Webster Lake. Frequent high levels of conductivity correspond to very low flows. This is typical of other years. pH is virtually always lower here than upstream at Webster Nursery, observed over the last twelve years.

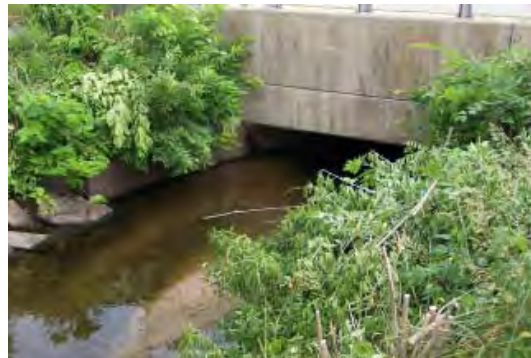
Mill Brook at Webster Nursery, Webster N 42°03'45.0" W 71°51'50.3"

Mill Brook at Webster Nursery (reference): measures the quality of water leaving Webster Lake, and serves as a reference point above the former stump grinding operation. Park in the mall parking lot and monitor on the west side of the bridge.

Water here is generally clear and odorless. There is some trash scattered about the site, and algae and small attached plants were seen on occasion. High levels of conductivity were observed three times which is consistent with that seen downstream at Bigelow Road during low flow. The high turbidity reading is related to bottom sediment interference. Runoff from the new mall does not seem to be changing the water characteristics.

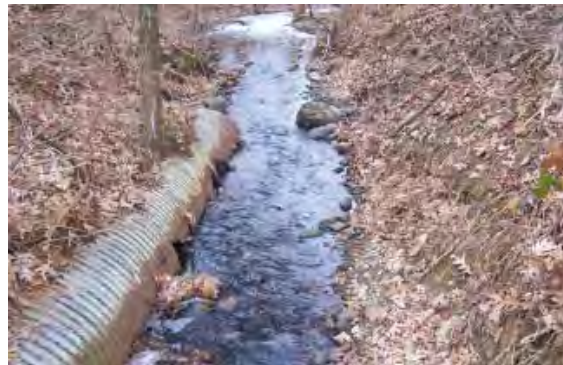
Nancy Drive, Webster N 42°04'41.2" W 71°52'28.0"

Nancy Drive (impact): an unnamed stream on the east side of the river in Webster near the Oxford line, which receives water from an industrial park and a casual junkyard, possibly carrying pollutants of all types. High conductivity levels have been measured here in the past. Take Nancy Drive from Route 12 and park at the end. Walk to the right by the house to a wooden bridge and monitor downstream.

Water here is clear and odorless. The extreme high levels of conductivity and low levels of DO, far below state standards, are typical of this site. DO failed to meet state standards on four occasions.

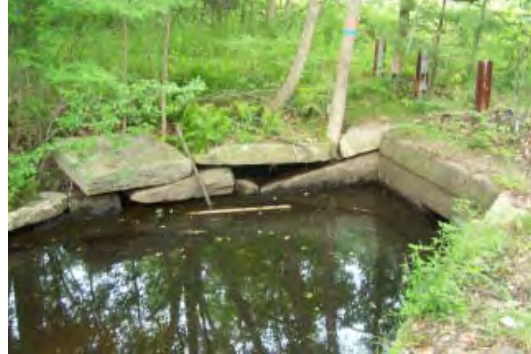
Old Mill Brook, Oxford N 42°05'19.1" W 71°52'15.1"

Old Mill Brook (impact): carries a significant volume of water and flows through two industrial parks, which may be sources of pollution. Park on Route 12 under the railroad overpass and Old Mill Brook is on the west side. Monitor where it emerges from the culvert under Route 12.

The water here is clear and odorless. Low DO values which are quite typical of this site were not observed this year. The elevated levels of conductivity that were observed in 2014, 2015, and 2016 have returned this year.

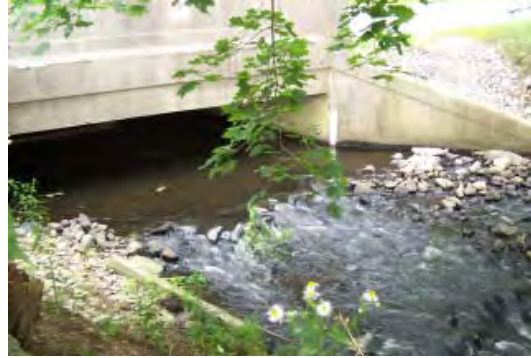
Lowe's Brook, Oxford N 42°06'14.7" W 71°51'58.8"

Lowe's Brook (impact): The largest brook that we measure flowing into the French River, except for the Little River, drains Lowe Pond, above which significant commercial development is taking place, which may be resulting in runoff now from development, and in the future from operation. Park at the small convenience store on the east side where Lowe's Brook crosses Route 12. Monitor from the bridge over the small diagonally running road (State Street) behind the store.

The water here is clear and odorless. There is trash scattered around the site. It is noteworthy that between 2010 and 2015, Lowe's Brook had at least one occasion in which DO values were below state DO standards. High Conductivity was observed once this year

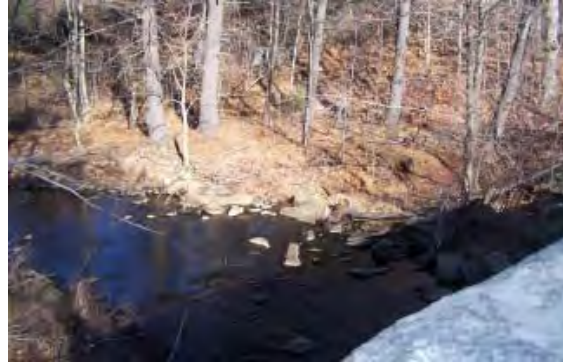
Clara Barton Road, Oxford N 42°09'14.2" W 71°52'57.3"

Clara Barton Road (reference): This site is upstream of gravel pit operations in the area. Take Clara Barton Road off Route 12 in North Oxford. Park at the stone bridge and monitor off the bridge.

Water here is clear and odorless. High conductivity values were observed on one occasion.

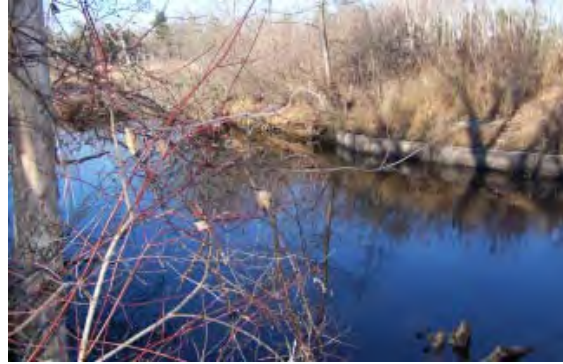
Little River, Oxford N 42°06'34.1" W 71°53'00.3"

The Little River (impact): this site is the largest inflow of water into the French River; it is the outflow from Buffumville Lake. Between Buffumville Lake and its confluence with the French River there are several industrial areas right on the river. We are monitoring here to see if there are any adverse effects from these sites. Where Dudley Road crosses over the French River there is a public parking lot at the Leovich Landing boat launch site. Park here and walked down the old Boston & Albany railbed about ¼ mile and monitor the Little River when reached

Water here is clear and odorless. There are grassy plants visible. The Little River failed to meet DO standards once in 2012, but that had not been seen before and was not repeated in the last five years.

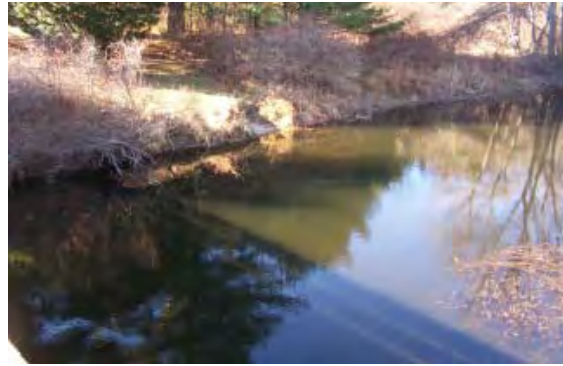
Dudley Road, Oxford N 42°06'25.5" W 71°52'58.4"

Dudley Road (reference): This site is above Lowe's Brook and is monitored as a baseline to see how much influence Lowe's Brook has on the French River. Park in the same location as for Little River and monitor off the bridge.

The water here is clear and odorless, with grasses observed at mid-season. There has been a summertime dip in DO since we started observing in 2007

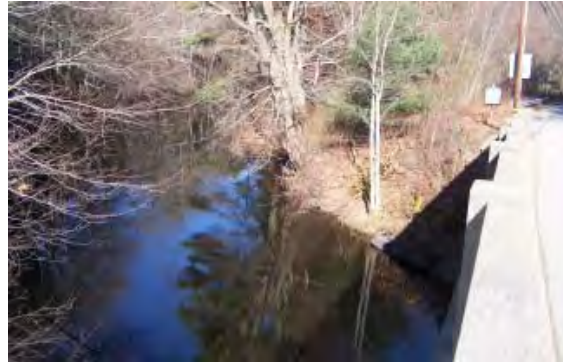
Harwood Street , Oxford N 42°05'28.6" W 71°52'48.7"

Harwood Street (reference): This site is below Lowe's Brook and combined with Dudley Road should give us a clear picture of any impact Lowe's has on the French River. Monitoring here also gives us a good flow measurement above North Village dam to compare with flow below as measured by the USGS gauge in Webster. There is a pull off next to the bridge where Harwood Street crosses over the French River. Park here and monitor off the bridge

The water here is clear and odorless.

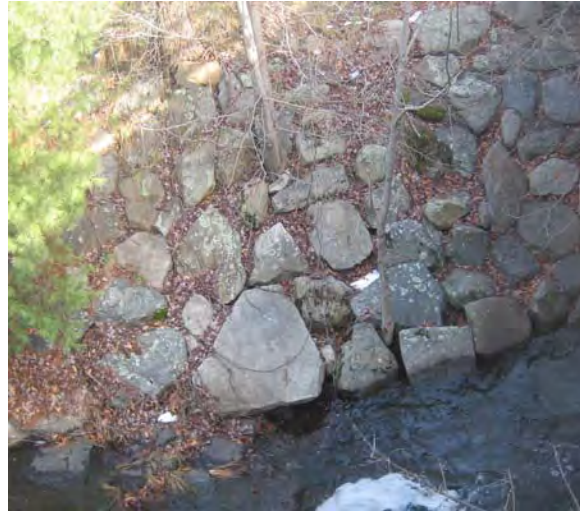
Route 56, Oxford N 42.16345° W 71.888340°

Route 56 (reference): It is the furthest upstream site that we will be monitoring and gives us a baseline for all downstream monitoring. Take Route 56 off Route 12 in North Oxford. Park at the bridge and monitor off the bridge.

Water here is clear and odorless. High turbidity was observed on one occasion and may be associated with air bubbles.

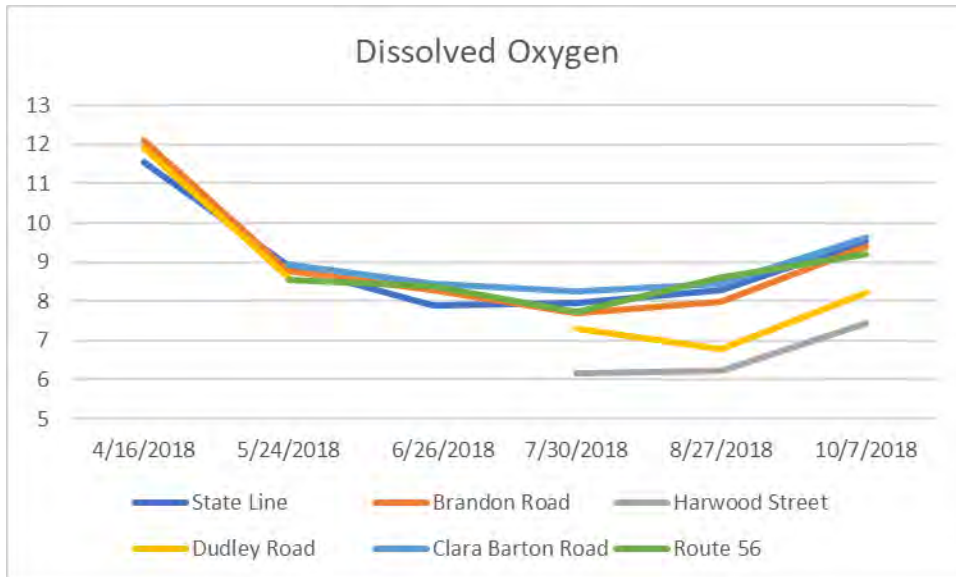
French River Dissolved Oxygen (mg/l)

It is usual to observe Clara Barton, State Line, Brandon Road, and Route 56 exhibiting higher levels of dissolved oxygen throughout the season. Dudley Road and Harwood Street exhibited lower levels but not as low as last year. There was not sufficient data to evaluate the “dip” shown in previous years. Dudley Road was not as low as last year.

These have been compared with charts from previous years, and we find that the similarity continues. If there is a negative trend to watch, it may be that the dissolved oxygen “dip” at Dudley Road and Harwood Street is becoming deeper and/or broader. The lack of dissolved oxygen data for 6/26 for the Dudley Road and Harwood Street sites limits the evaluation of the “dip” this year. It appears that the negative trend did continue this year. This trend will continue to be monitored.

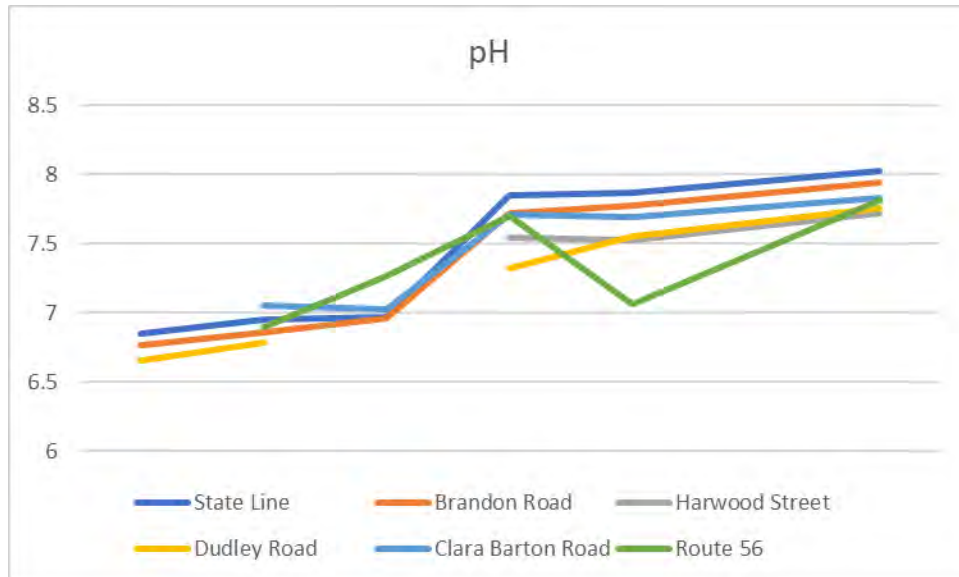
French River pH

The values of pH, and the relative positions of the lines representing each station, are similar to the previous years. We generally find Clara Barton, State Line, Brandon Road and Route 56 within a 0.5 pH range. This is not true on every date, but most often it is. pH tended to be higher this year.

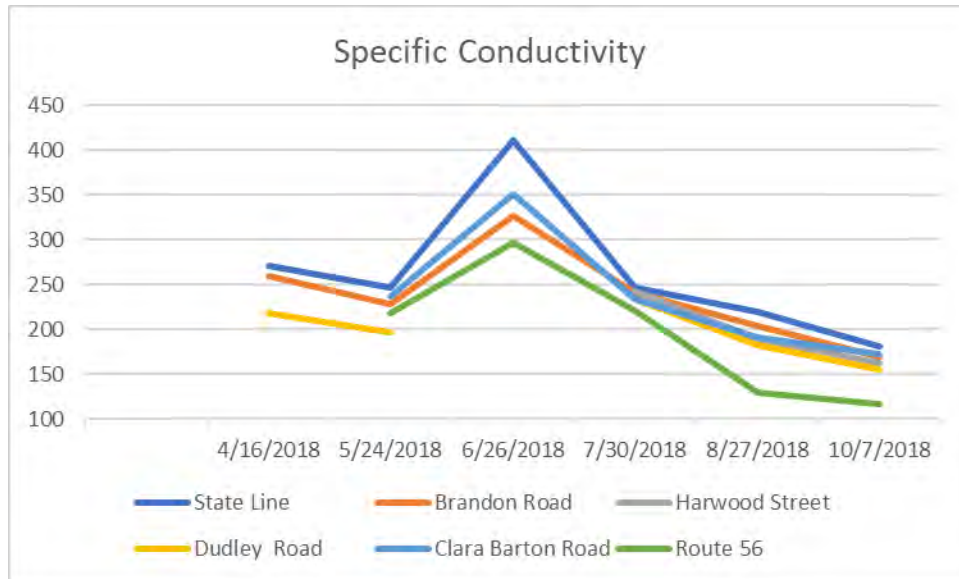
French River Specific Conductivity (uSm/cm)

The low river flow for the 6/26 sampling resulted in a high specific conductivity for all sites. The high river flow for the 8/27 and 10/7 sampling resulted in low specific conductivity for all sites.

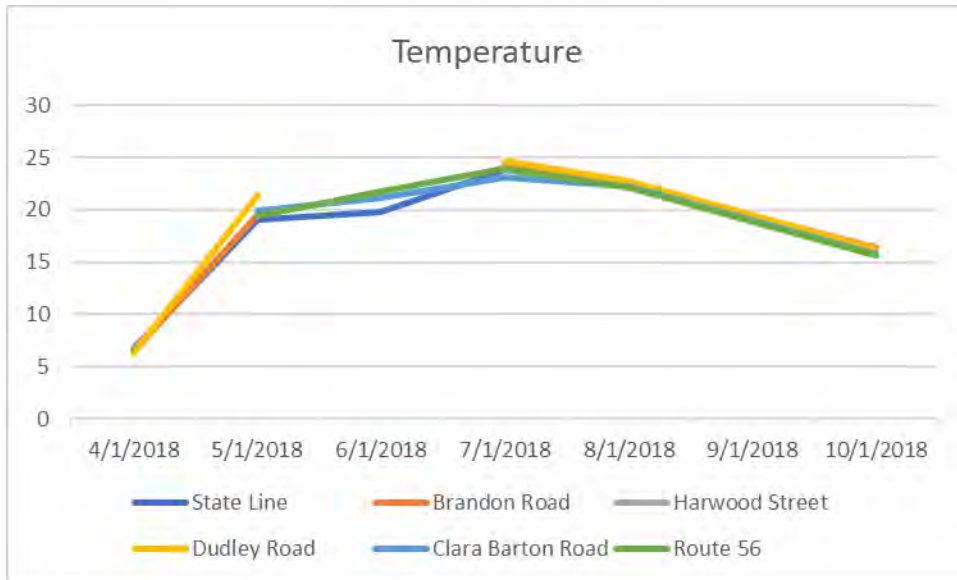
French River Temperature (°C)

Water temperature is extremely weather dependent, and always very similar over the length of the river. The highest temperature was recorded at Dudley Road. Water temperatures are higher than last year.
