French River Connection

2020 Water Quality Monitoring Report

NOVEMBER 20, 2020

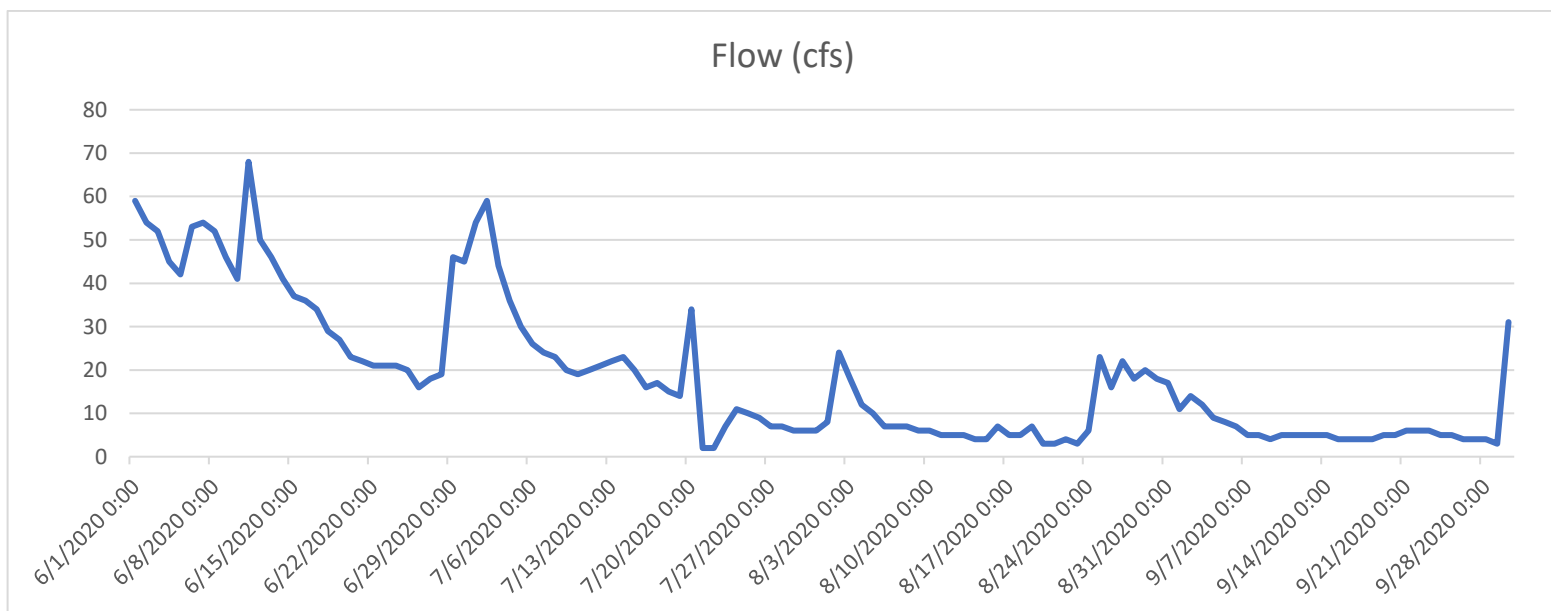
The flow rate at the time of sampling can possibly impact parameter values. The flow rate of the French River at the Army Corp of Engineers gage site in Webster, MA is illustrated in the graph below. The flow rate at this gage station is in general indicative of the flow rate at all sample sites except for the Mill Brook sites. The flow rate in Mill Brook is controlled at the Webster Lake outlet.

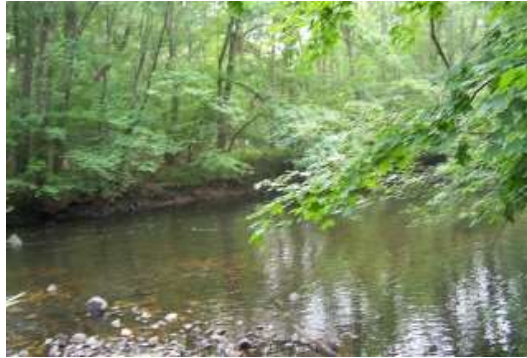
State Line, Webster N 42°02'27.5" W 71°53'02"

Stateline (boundary): this is a measure of water quality, below the Webster WWTP, as the main stem leaves the state. This site is chosen because it is on the state line. It is reached by parking where the P&W active rail line crosses Perryville Road in Webster and walking diagonally downstream until the river is reached.

Water at this site is clear and odorless. Elevated conductivity was observed as in previous years and may be related to low flow this year. The dam overflow just upstream contributes to the amount of dissolved oxygen at this site.

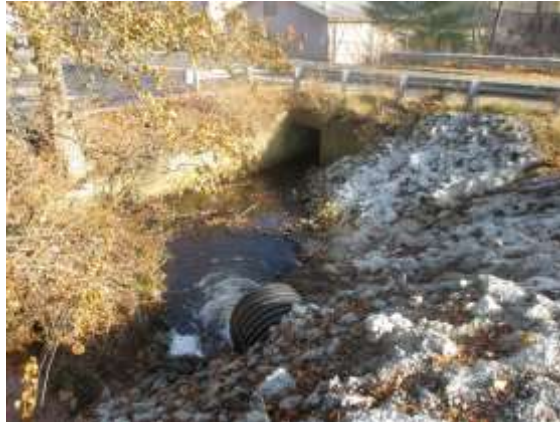
Packard Pond Outflow, Dudley N 42°01'1.0" W 71°53'25.5"

Packard Pond (impact): carries a significant volume of water and drains Ardlock Acres conservation area and an area behind the Dudley transfer station, which may be a source of pollution. Park at the junction of Carpenter Road and Route 12 in Dudley, and monitor on the west side of the culvert.

Water at this site is normally clear and odorless. There are small articles of trash scattered about, and plants along the sides of the channel. DO reading was below State standards three times. pH was below 6.5 once.

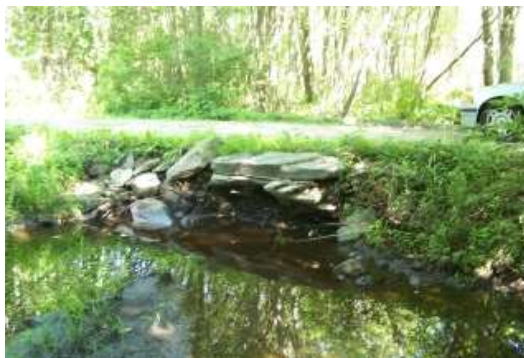
Potash Brook, Dudley N 42°02'13.5" W 71°53'33.3"

Potash Brook : carries a significant volume of water and drains an area west of Merino Pond which is partly residential and partly agricultural and may be a source of nutrient runoff. Turn off Route 12 onto New Boston Road and then right into the Dudley Pumping Station, and monitor on the south side of the bridge.

Water here is clear and odorless. Water temperatures here are generally the lowest we observe. The E. Coli and conductivity values at this site are normally high

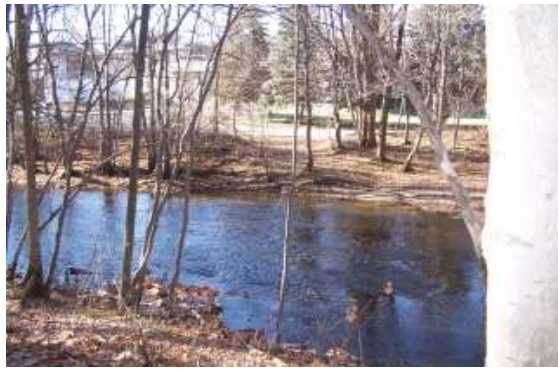
Brandon Road, Dudley N 42°02'30.2" W 71°53'14.8"

Brandon Road (reference): At this location we can take data upstream of the Webster Wastewater Treatment Plant. Drive into the Ethan Allen Mill Complex north of the office and proceed directly to the river, just downstream from the Hill Street bridge

Water here is clear and odorless. High conductivity was observed once.

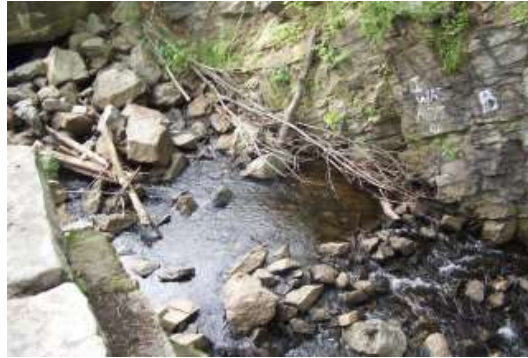
Low Pond Outflow, Dudley N 42°02'59.8" W 71°53'16.3"

Low Pond outflow (impact): carries a significant volume of water and drains a string of ponds including Low Pond and Merino Pond, around which there are significant residential developments which may be a source of runoff. Park on the north side of Stevens Linen in Dudley in the large parking lot and proceed to the right to the tailrace. Monitor where it emerges from under the building.

Water here is generally clear and odorless.

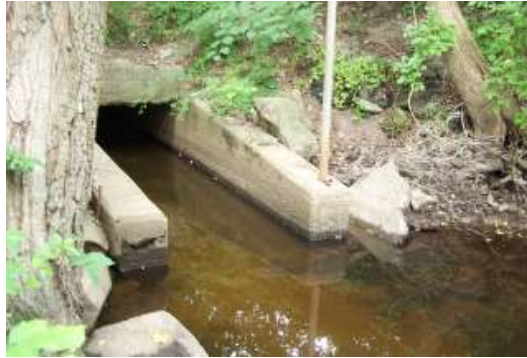
Commerce Parking Lot Storm Drain, Webster N 42°03'01.4" W 71°53'00.6"

Commerce parking lot storm drain (impact):
This continually running storm drain in downtown Webster has exuded an odor detectable at times and nearby rocks have exhibited an orange deposit. High E. Coli counts were found at this site. This is a possible point source of pollution. Enter the public parking lot at Tracy Court and go to the southwest corner. Monitor the storm drain outflow.

There is some trash scattered about. Consistently higher levels of conductivity, E. Coli, and pH characterize this site. Normal pH levels were observed this year.

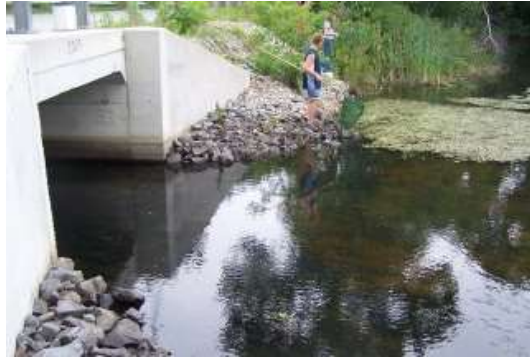
Mill Brook at Bigelow Road, Webster N 42°04'00.8" W 71°52'31.9"

Mill Brook at Bigelow Road (impact): As the outflow from Webster Lake, carries a significant volume of water. This station is downstream from a former stump grinding operation, which operated on raw material of unknown origin and character, and added chemicals to its product, and may have affected the chemistry of Mill Brook. Park near the bridge over Mill Brook on Bigelow Road, and monitor on the east side of the bridge.

Water here is very clear and odorless. There is considerable trash scattered about, and plants seen throughout the season include milfoil, algae, water lilies, cattails, and many others. Flow here is affected by operation of a dam controlling the level of Webster Lake. Frequent high levels of conductivity correspond to very low flows. This is typical of other years. pH is virtually always lower here than upstream at Webster Nursery, observed over the last thirteen years. The low DO levels may be related to the very low flow in Mill Brook this summer. High conductivity was observed three times and low DO twice.

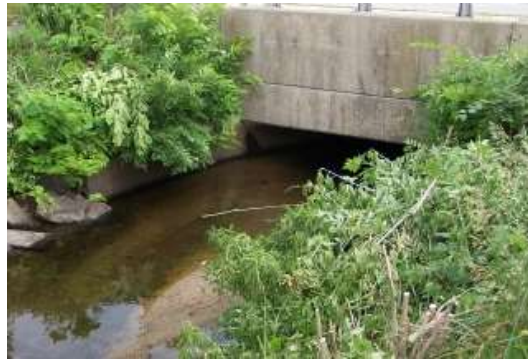
Mill Brook at Webster Nursery, Webster N 42°03'45.0" W 71°51'50.3"

Mill Brook at Webster Nursery (reference): measures the quality of water leaving Webster Lake, and serves as a reference point above the former stump grinding operation. Park in the mall parking lot and monitor on the west side of the bridge.

Water here is generally clear and odorless. There is some trash scattered about the site, and algae and small attached plants were seen on occasion. High levels of conductivity were observed three times which is consistent with that seen downstream at Bigelow Road during low flow. Runoff from the new mall does not seem to be changing the water characteristics.

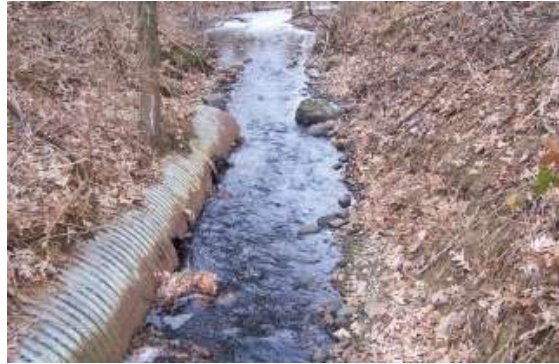
Nancy Drive, Webster N 42°04'41.2" W 71°52'28.0"

Nancy Drive (impact): an unnamed stream on the east side of the river in Webster near the Oxford line, which receives water from an industrial park and a casual junkyard, possibly carrying pollutants of all types. High conductivity levels have been measured here in the past. Take Nancy Drive from Route 12 and park at the end. Walk to the right by the house to a wooden bridge and monitor downstream.

Water here is clear and odorless. The high levels of conductivity and low levels of DO, far below state standards, are typical of this site. However, low DO levels were not observed this year

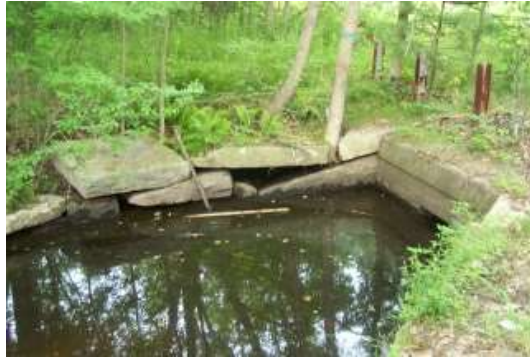
Old Mill Brook, Oxford N 42°05'19.1" W 71°52'15.1"

Old Mill Brook (impact): carries a significant volume of water and flows through two industrial parks, which may be sources of pollution. Park on Route 12 under the railroad overpass and Old Mill Brook is on the west side. Monitor where it emerges from the culvert under Route 12.

The water here is clear and odorless. Low DO values which are quite typical of this site were only observed once this year. The elevated levels of conductivity that were observed in 2014,2015, 2016, 2018 and 2019 have returned this year.

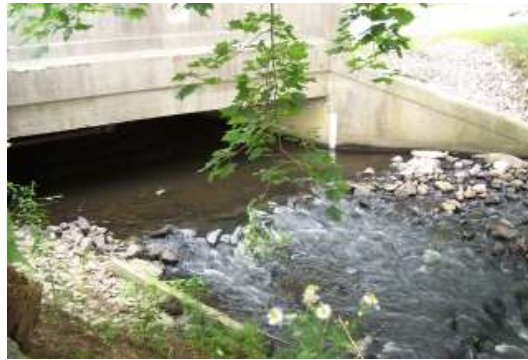
Lowe's Brook, Oxford N 42°06'14.7" W 71°51'58.8"

Lowe's Brook (impact): The largest brook that we measure flowing into the French River, except for the Little River, drains Lowe Pond, above which significant commercial development is taking place, which may be resulting in runoff now from development, and in the future from operation. Park at the small convenience store on the east side where Lowe's Brook crosses Route 12. Monitor from the bridge over the small diagonally running road (State Street) behind the store.

The water here is clear and odorless. There is trash scattered around the site. It is noteworthy that between 2010 and 2015, Lowe's Brook had at least one occasion in which DO values were below state DO standards. High conductivity was observed twice this year

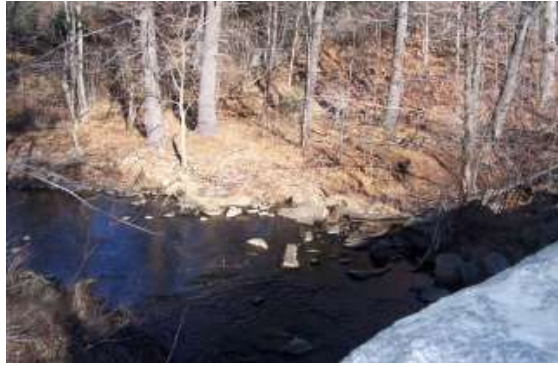
Clara Barton Road, Oxford N 42°09'14.2" W 71°52'57.3"

Clara Barton Road (reference): This site is upstream of gravel pit operations in the area. Take Clara Barton Road off Route 12 in North Oxford. Park at the stone bridge and monitor off the bridge.

Water here is clear and odorless. High conductivity was observed on one occasion.

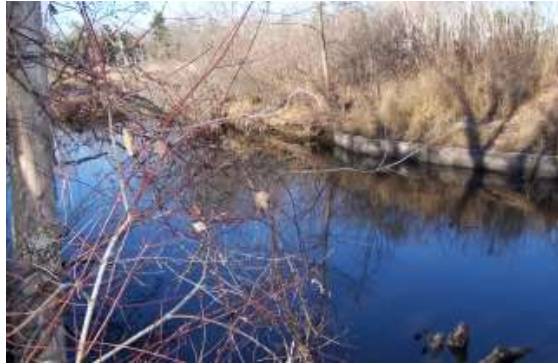
Little River, Oxford N 42°06'34.1" W 71°53'00.3"

The Little River (impact): this site is the largest inflow of water into the French River; it is the outflow from Buffumville Lake. Between Buffumville Lake and its confluence with the French River there are several industrial areas right on the river. We are monitoring here to see if there are any adverse effects from these sites. Where Dudley Road crosses over the French River there is a public parking lot at the Leovich Landing boat launch site. Park here and walked down the old Boston & Albany railbed about ¼ mile and monitor the Little River when reached

Water here is clear and odorless. There are grassy plants visible. The Little River failed to meet DO standards once in 2012, but that had not been seen before and was not repeated in the last eight years.

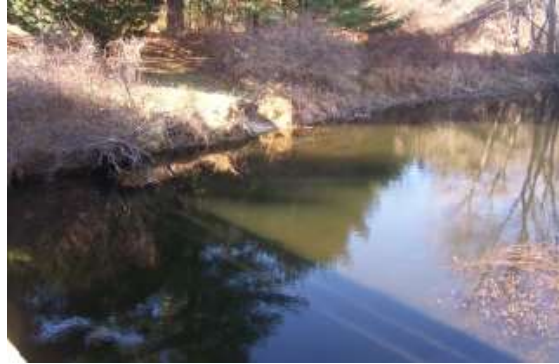
Dudley Road, Oxford N 42°06'25.5" W 71°52'58.4"

Dudley Road (reference): This site is above Lowe's Brook and is monitored as a baseline to see how much influence Lowe's Brook has on the French River. Park in the same location as for Little River and monitor off the bridge.

The water here is clear and odorless, with grasses observed at mid-season. There has been a summertime dip in DO since we started observing in 2007. High conductivity was observed on one occasion.

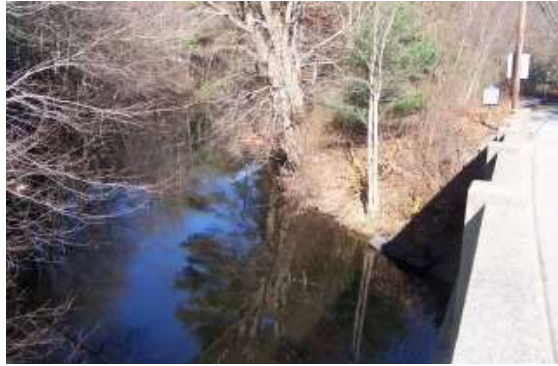
Harwood Street , Oxford N 42°05'28.6" W 71°52'48.7"

Harwood Street (reference): This site is below Lowe's Brook and combined with Dudley Road should give us a clear picture of any impact Lowe's has on the French River. Monitoring here also gives us a good flow measurement above North Village dam to compare with flow below as measured by the USGS gauge in Webster. There is a pull off next to the bridge where Harwood Street crosses over the French River. Park here and monitor off the bridge

The water here is clear and odorless. High conductivity was observed on one occasion.

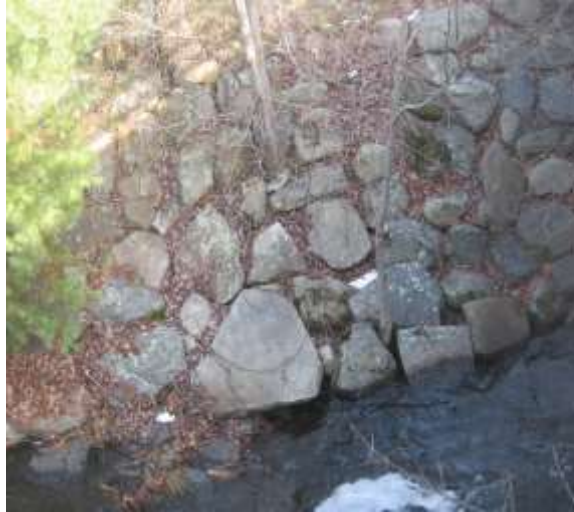
Route 56, Oxford N 42.16345° W 71.888340°

Route 56 (reference): It is the furthest upstream site that we will be monitoring and gives us a baseline for all downstream monitoring. Take Route 56 off Route 12 in North Oxford. Park at the bridge and monitor off the bridge.

Water here is clear and odorless. High conductivity and low DO were observed on one occasion each.

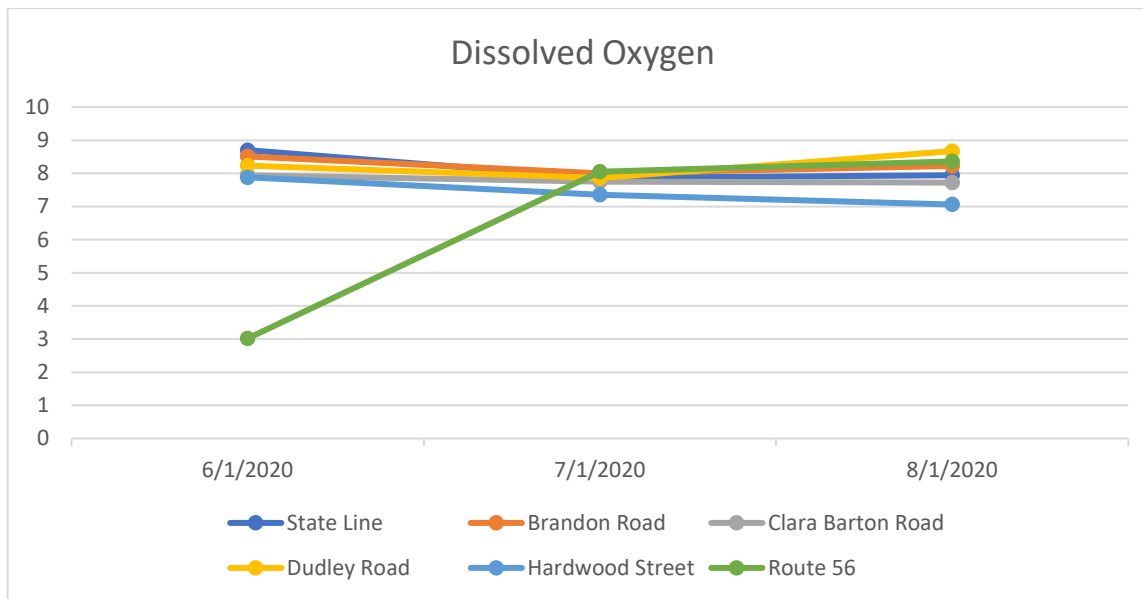
French River Dissolved Oxygen (mg/l)

It is usual to observe Clara Barton, State Line, Brandon Road, and Route 56 exhibiting higher levels of dissolved oxygen throughout the season. There is no apparent reason for the low DO at Route 56 on 6/17. Dudley Road indicated a “dip” as in previous years, but the “dip” was not as low. Harwood Street did not exhibit a “dip” this year but DO levels were lower than last year.

These have been compared with charts from previous years, and we find that the similarity continues. A negative trend that we have been watching is a dissolved oxygen “dip” at Dudley Road and Harwood Street has been becoming deeper and/or broader. This was less significant this year.

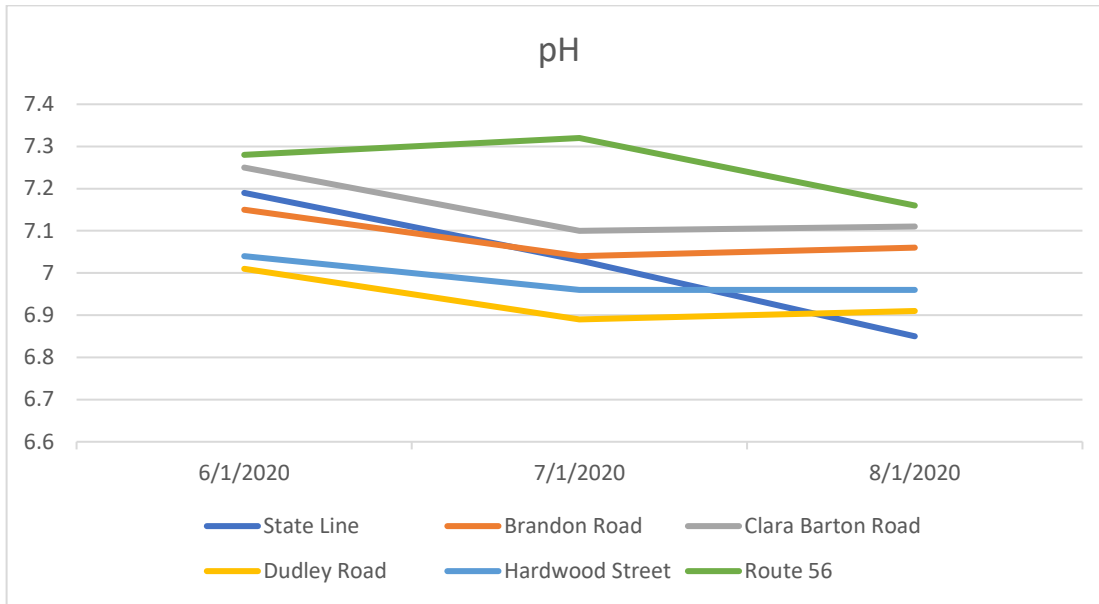
French River pH

The values of pH, and the relative positions of the lines representing each station, are similar to the previous years. We generally find Clara Barton, State Line, Brandon Road and Route 56 within a 0.5 pH range. This is not true on every date, but most often it is. pH tended to be lower this year.

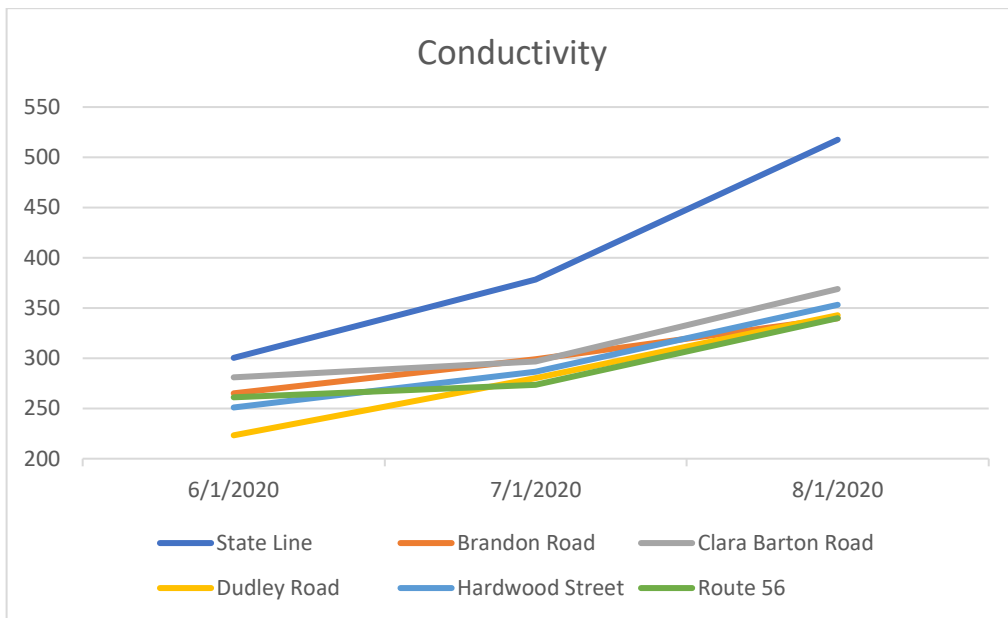
French River Specific Conductivity (uSm/cm)

Conductivity was higher this year than last and this is most likely related to low flow. The higher levels at State Line could be related to the Webster WWTP discharge which would have a greater impact on river water quality due to the lower dilution at very low river flow rate.

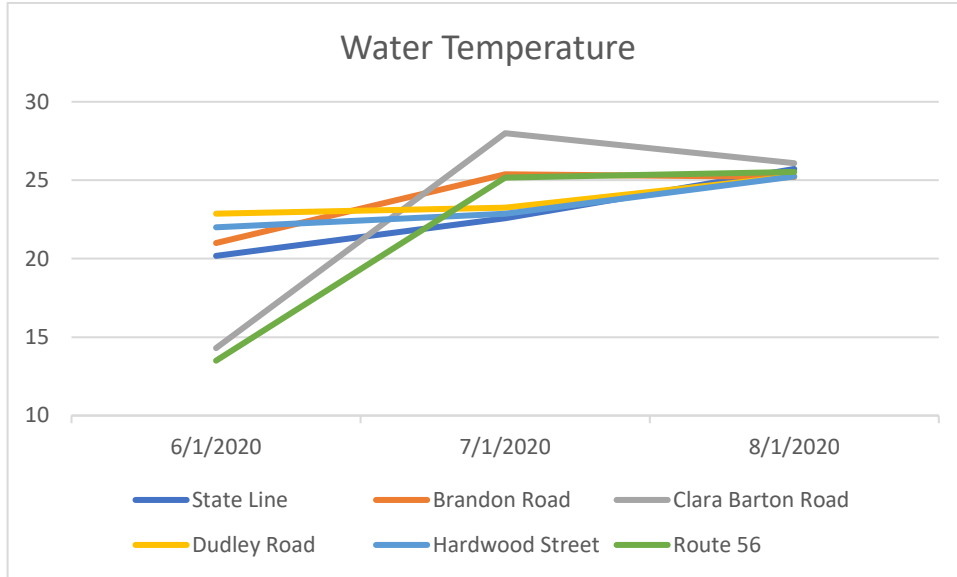
French River Temperature (°C)

Water temperature is extremely weather dependent, and always very similar over the length of the river. The highest temperature was recorded at Clara Barton Road.
