# *French River Connection*

## **2019 Water Quality Monitoring Report**

**JANUARY 4, 2020**

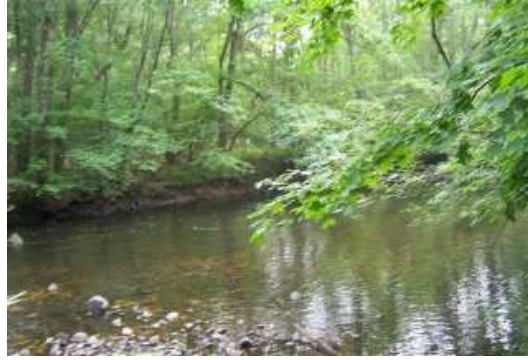
**State Line, Webster** N 42°02'27.5" W 71°53'02"

Stateline (boundary): this is a measure of water quality, below the Webster WWTP, as the main stem leaves the state. This site is chosen because it is on the state line. It is reached by parking where the P&W active rail line crosses Perryville Road in Webster and walking diagonally downstream until the river is reached.

Water at this site is clear and odorless. Elevated conductivity has been observed in previous years but seems to be within spec this year. The waterfall just upstream contributes to the amount of dissolved oxygen at this site.

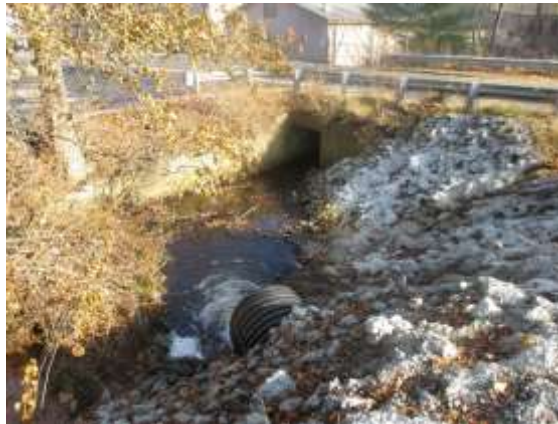
**Packard Pond Outflow, Dudley N 42°01'1.0" W 71°53'25.5"**

Packard Pond (impact): carries a significant volume of water and drains Ardlock Acres conservation area and an area behind the Dudley transfer station, which may be a source of pollution. Park at the junction of Carpenter Road and Route 12 in Dudley, and monitor on the west side of the culvert.

Water at this site is normally clear and odorless. There are small articles of trash scattered about, and plants along the sides of the channel. DO reading was below State standards twice. pH was below 6.5 once.

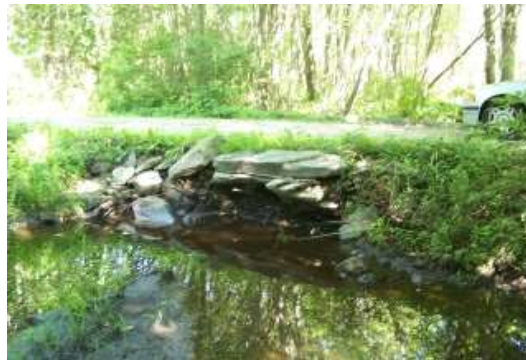
**Potash Brook, Dudley** N 42°02'13.5" W 71°53'33.3"

Potash Brook : carries a significant volume of water and drains an area west of Merino Pond which is partly residential and partly agricultural and may be a source of nutrient runoff. Turn off Route 12 onto New Boston Road and then right into the Dudley Pumping Station, and monitor on the south side of the bridge.

\* Conductivity was generally high throughout the season at this site.

Water here is clear and odorless. Water temperatures here are generally the lowest we observe. The E. Coli values for July and August are high. In an attempt to determine a possible source a sample was taken approximately 300 feet upstream on 9/16. The value was 12.0 which similar to the 17.4 value taken at the Potash Brook site. Additional upstream sampling will be conducted next year.

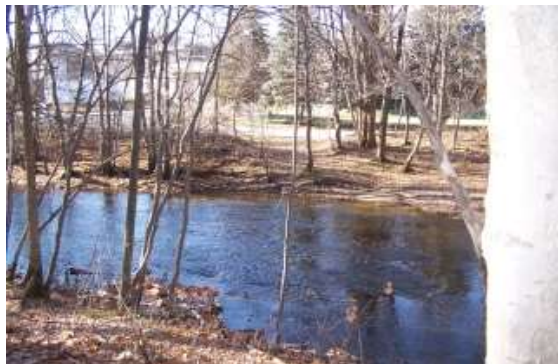
**Brandon Road, Dudley N 42°02'30.2" W 71°53'14.8"**

Brandon Road (reference): At this location we can take data upstream of the Webster Wastewater Treatment Plant. Drive into the Ethan Allen Mill Complex north of the office and proceed directly to the river, just downstream from the Hill Street bridge

Water here is clear and odorless.

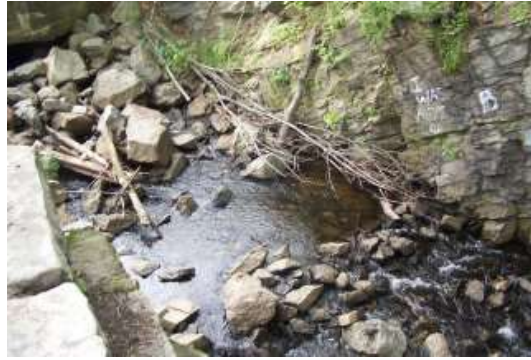
**Low Pond Outflow, Dudley** N 42°02'59.8" W 71°53'16.3"

Low Pond outflow (impact): carries a significant volume of water and drains a string of ponds including Low Pond and Merino Pond, around which there are significant residential developments which may be a source of runoff. Park on the north side of Stevens Linen in Dudley in the large parking lot and proceed to the right to the tailrace. Monitor where it emerges from under the building.

Water here is generally clear and odorless. There is some trash in the channel.

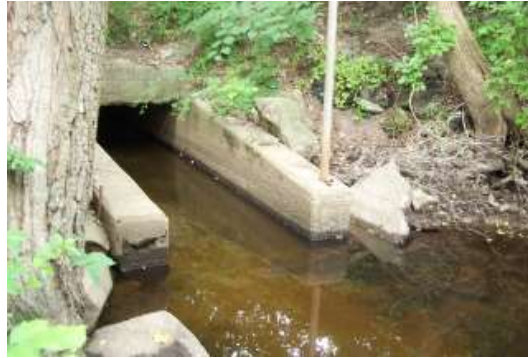
**Commerce Parking Lot Storm Drain, Webster** N 42°03'01.4" W 71°53'00.6"

Commerce parking lot storm drain (impact):  
This continually running storm drain in downtown Webster has exuded an odor detectable at times and nearby rocks have exhibited an orange deposit. High E. Coli counts were found at this site. This is a possible point source of pollution. Enter the public parking lot at Tracy Court and go to the southwest corner. Monitor the storm drain outflow.

\*Heavy sediment washed in from a construction project which caused some of the high readings.

There is some trash scattered about. Consistently higher levels of conductivity, E. Coli, and pH characterize this site.

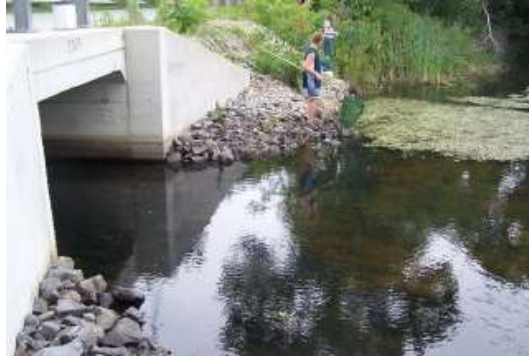
**Mill Brook at Bigelow Road, Webster** N 42°04'00.8" W 71°52'31.9"

Mill Brook at Bigelow Road (impact): As the outflow from Webster Lake, carries a significant volume of water. This station is downstream from a former stump grinding operation, which operated on raw material of unknown origin and character, and added chemicals to its product, and may have affected the chemistry of Mill Brook. Park near the bridge over Mill Brook on Bigelow Road, and monitor on the east side of the bridge.

Water here is very clear and odorless. There is considerable trash scattered about, and plants seen throughout the season include milfoil, algae, water lilies, cattails, and many others. Flow here is affected by operation of a dam controlling the level of Webster Lake. Frequent high levels of conductivity correspond to very low flows. This is typical of other years. pH is virtually always lower here than upstream at Webster Nursery, observed over the last twelve years. The pH relationship was not as strong this year and that may be related to the very low flow in Mill Brook this summer.

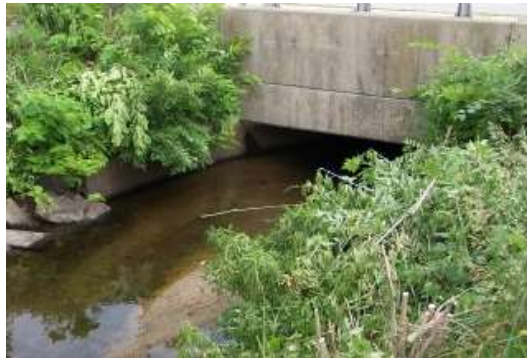
**Mill Brook at Webster Nursery, Webster N 42°03'45.0" W 71°51'50.3"**

Mill Brook at Webster Nursery (reference): measures the quality of water leaving Webster Lake, and serves as a reference point above the former stump grinding operation. Park in the mall parking lot and monitor on the west side of the bridge.

Water here is generally clear and odorless. There is some trash scattered about the site, and algae and small attached plants were seen on occasion. High levels of conductivity were observed three times which is consistent with that seen downstream at Bigelow Road during low flow. Runoff from the new mall does not seem to be changing the water characteristics. There were no samples on 8/9 because the flow was too low to sample.

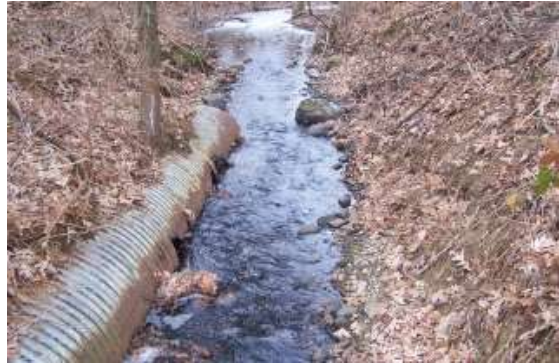
**Nancy Drive, Webster** N 42°04'41.2" W 71°52'28.0"

Nancy Drive (impact): an unnamed stream on the east side of the river in Webster near the Oxford line, which receives water from an industrial park and a casual junkyard, possibly carrying pollutants of all types. High conductivity levels have been measured here in the past. Take Nancy Drive from Route 12 and park at the end. Walk to the right by the house to a wooden bridge and monitor downstream.

Water here is clear and odorless. The extreme high levels of conductivity and low levels of DO, far below state standards, are typical of this site. DO failed to meet state standards on four occasions.

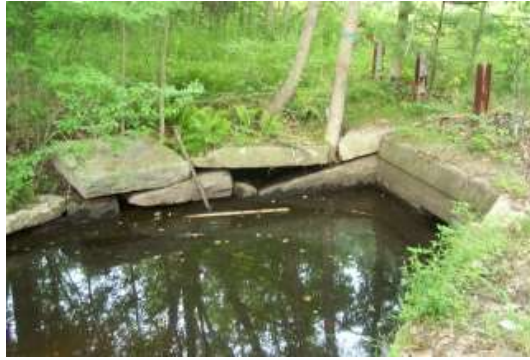
**Old Mill Brook, Oxford** N 42°05'19.1" W 71°52'15.1"

Old Mill Brook (impact): carries a significant volume of water and flows through two industrial parks, which may be sources of pollution. Park on Route 12 under the railroad overpass and Old Mill Brook is on the west side. Monitor where it emerges from the culvert under Route 12.

The water here is clear and odorless. Low DO values which are quite typical of this site were only observed once this year. The elevated levels of conductivity that were observed in 2014,2015, 2016, and 2018 have returned this year.

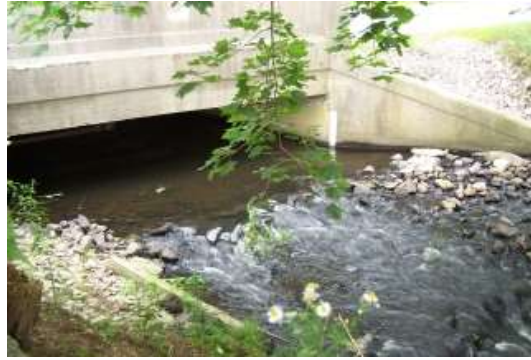
**Lowe's Brook, Oxford** N 42°06'14.7" W 71°51'58.8"

Lowe's Brook (impact): The largest brook that we measure flowing into the French River, except for the Little River, drains Lowe Pond, above which significant commercial development is taking place, which may be resulting in runoff now from development, and in the future from operation. Park at the small convenience store on the east side where Lowe's Brook crosses Route 12. Monitor from the bridge over the small diagonally running road (State Street) behind the store.

The water here is clear and odorless. There is trash scattered around the site. It is noteworthy that between 2010 and 2015, Lowe's Brook had at least one occasion in which DO values were below state DO standards.

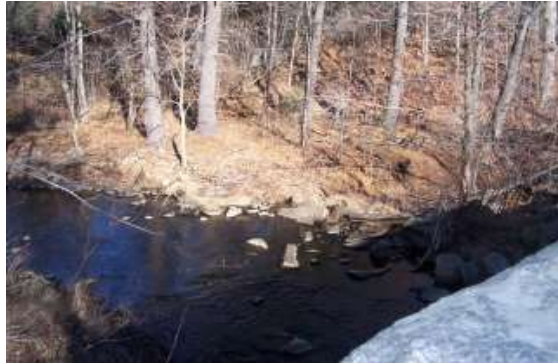
**Clara Barton Road, Oxford N 42°09'14.2" W 71°52'57.3"**

Clara Barton Road (reference): This site is upstream of gravel pit operations in the area. Take Clara Barton Road off Route 12 in North Oxford. Park at the stone bridge and monitor off the bridge.

Water here is clear and odorless. The conductivity values seemed to have lowered compared to last year. Rapids contribute to a high DO.

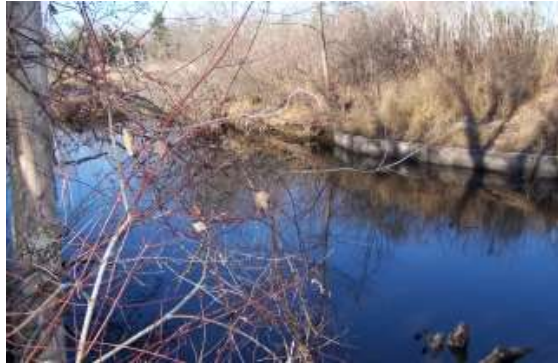
**Little River, Oxford** N 42°06'34.1" W 71°53'00.3"

The Little River (impact): this site is the largest inflow of water into the French River; it is the outflow from Buffumville Lake. Between Buffumville Lake and its confluence with the French River there are several industrial areas right on the river. We are monitoring here to see if there are any adverse effects from these sites. Where Dudley Road crosses over the French River there is a public parking lot at the Leovich Landing boat launch site. Park here and walked down the old Boston & Albany railbed about ¼ mile and monitor the Little River when reached

Water here is clear and odorless. There are grassy plants visible. The Little River failed to meet DO standards once in 2012, but that had not been seen before and was not repeated in the last five years.

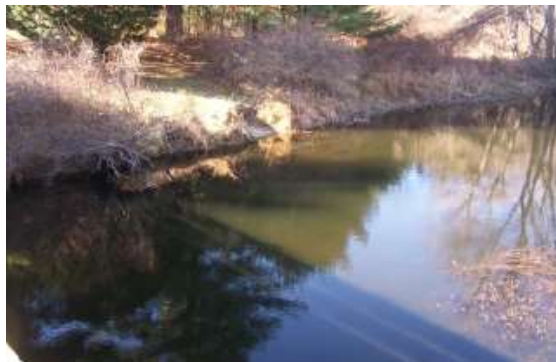
**Dudley Road, Oxford** N 42°06'25.5" W 71°52'58.4"

Dudley Road (reference): This site is above Lowe's Brook and is monitored as a baseline to see how much influence Lowe's Brook has on the French River. Park in the same location as for Little River and monitor off the bridge.

The water here is clear and odorless, with grasses observed at mid-season. There has been a summertime dip in DO since we started observing in 2007

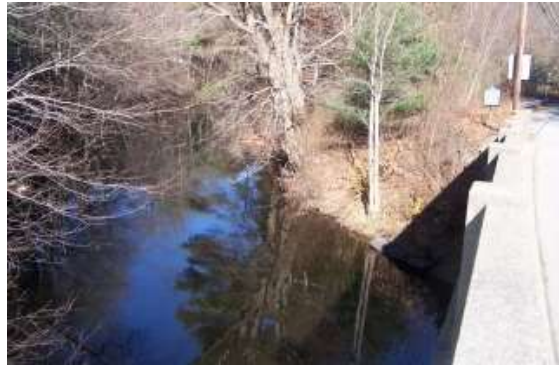
**Harwood Street , Oxford** N 42°05'28.6" W 71°52'48.7"

Harwood Street (reference): This site is below Lowe's Brook and combined with Dudley Road should give us a clear picture of any impact Lowe's has on the French River. Monitoring here also gives us a good flow measurement above North Village dam to compare with flow below as measured by the USGS gauge in Webster. There is a pull off next to the bridge where Harwood Street crosses over the French River. Park here and monitor off the bridge

The water here is clear and odorless.

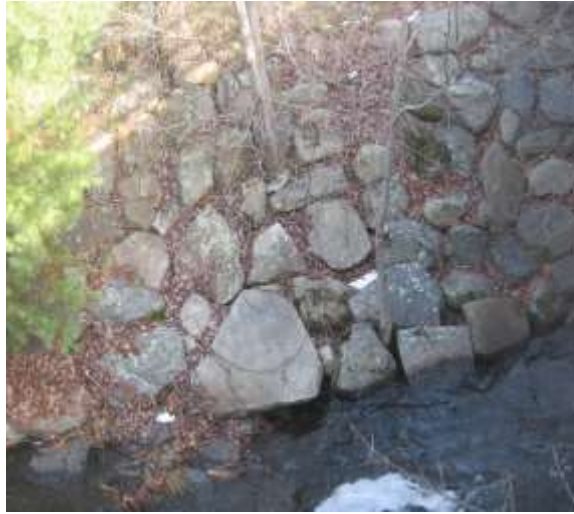
**Route 56, Oxford** N 42.16345° W 71.888340°

Route 56 (reference): It is the furthest upstream site that we will be monitoring and gives us a baseline for all downstream monitoring. Take Route 56 off Route 12 in North Oxford. Park at the bridge and monitor off the bridge.

Water here is clear and odorless. High turbidity was observed on one occasion and maybe associated with air bubbles.

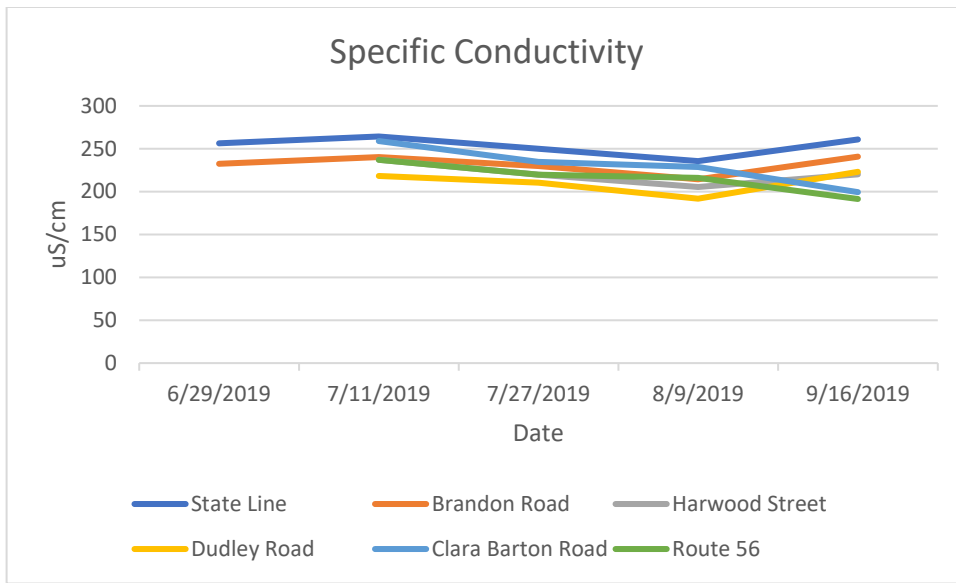
## French River Specific Conductivity (uSm/cm)

Issues with the conductivity probe for 6/29 prevented data to be collected for Harwood Street, Dudley Rd, Clara Barton Rd, and Rt. 56. Conductivity is usually stable at these sites.
